## 100 YEARS OF FATALITIES AND DESTROYED CIVIL AIRCRAFT DUE TO BIRD STRIKES

John Thorpe, FRAeS Aviation Safety Adviser & Former IBSC Chairman  
Brackens, Chapel Road, Smallfield, Surrey, RH6 9JH, UK  
0044 1342 842594, [johnthorpe@flysafe.fsnet.co.uk](mailto:johnthorpe@flysafe.fsnet.co.uk)

At the 1996 London and 2003 Warsaw meetings of the International Bird Strike Committee, illustrated Working Papers were presented that provided brief details of **all** known fatalities and destroyed aircraft due to bird strikes between 1912 and 2002. These papers were felt to be useful in drawing attention to the scale of the problem especially when dealing with those who know little about the subject or who are newly appointed to decision-making positions. Since the original papers were published, updated information has been provided in Papers presented at IBSC Meetings in Athens, Brasilia and Cairns. This 36 page Paper consolidates and updates the information and analysis.

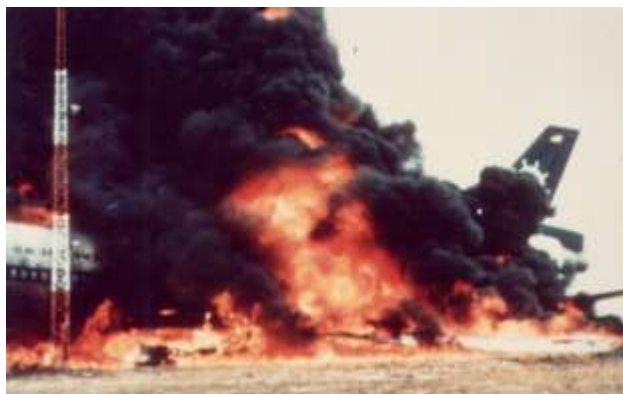
Gulls, DC10 Kennedy Airport, New York 1975 (airline staff – non fatal)

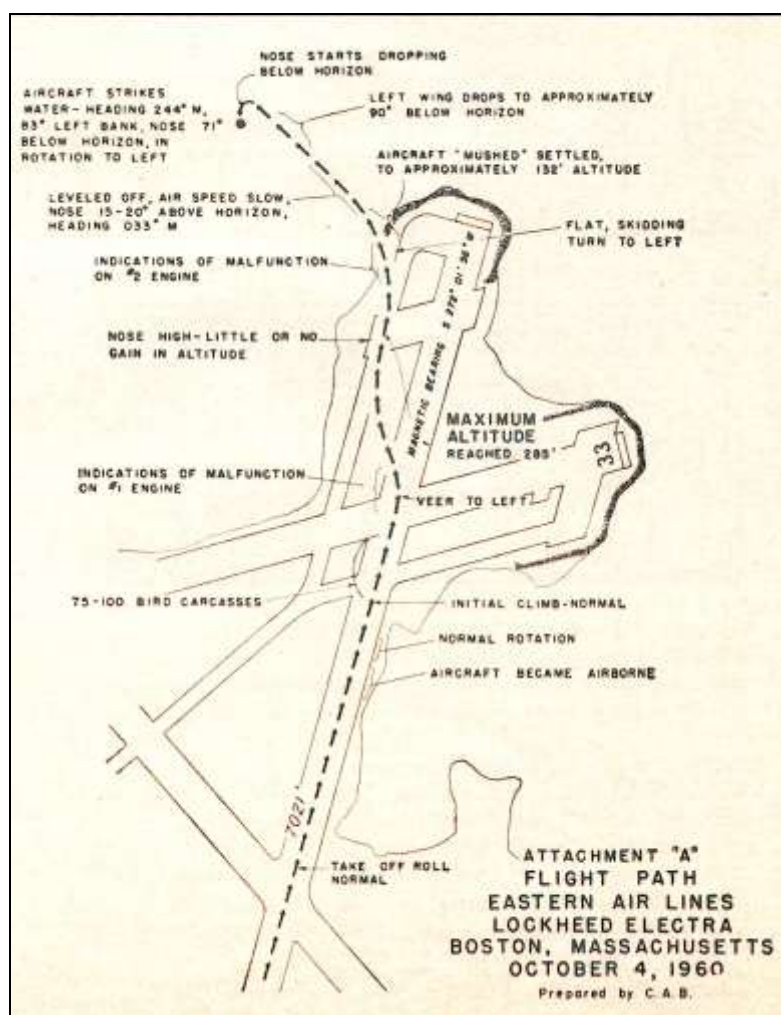
Date/ Regn.	Aircraft/ Engine	Location/ Country	Part Struck/ Birds	On Board/ Deaths
04.10.60 N5533	Lockheed L188 Electra 4 Allison 501 turboprop	Boston Airport, Mass, USA	Engines Starlings	72 <b>62 fatal</b> 9 serious injury

A few seconds after the Eastern Airlines flight became airborne from runway 09, the aircraft passed through a flock of **Starlings** (*Sturnus vulgaris*, 80 gm). A number were ingested in engines 1, 2 and 4. Engine 1 was shut down and its propeller auto-feathered. Numbers 2 and 4 experienced substantial intermittent loss of power which resulted in the aircraft yawing and decelerating to the stall speed, the left wing dropped, the nose pitched up and the aircraft rolled left into a spin and fell almost vertically into the water. About 75 carcasses were scattered over a large area. At least 4 birds were ingested in engine 1, about 6 in engine 2, which flamed out and re-lit and with less in number 4. This was the worst ever bird strike accident, 59 passengers and 3 crew died, and 9 passengers were seriously injured.

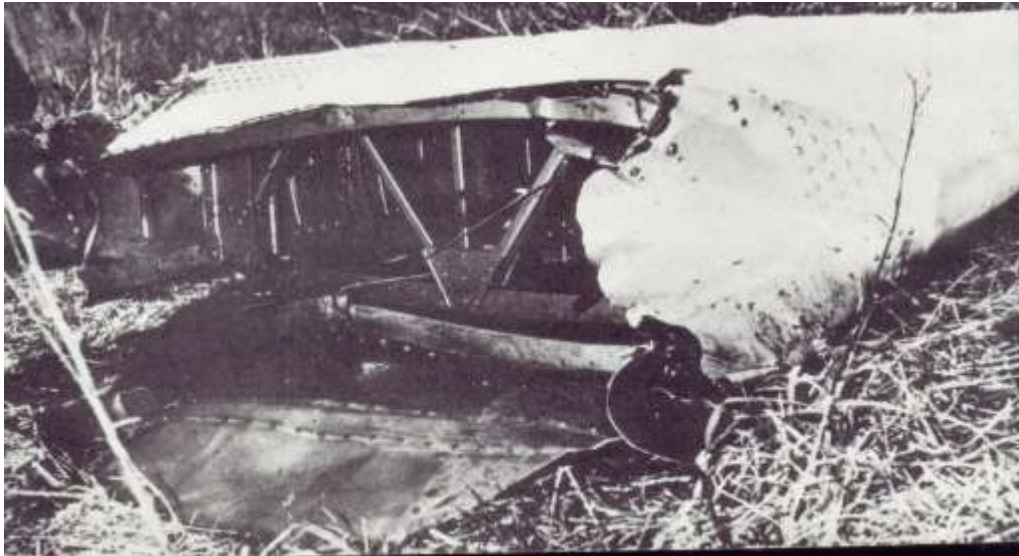
<b>23.11 62</b> N7430	<b>Vickers Viscount</b> 4 RR Dart turboprop	Ellicott City, Maryland, USA	Tailplane Whistling Swan	17 <b>17 fatal</b>
--------------------------	--	---------------------------------	-----------------------------	-----------------------

While the United Airlines flight was in the cruise at 6,000 ft en-route from New York, Newark to Washington at night, the aircraft struck **Whistling swans** (*Cygnus columbianus*, 6 kg). Two were struck, one holed the leading edge of the tailplane and exited from the rear surface damaging the elevator, weakening the structure causing the tailplane to detach and the aircraft to crash. As a result of this accident aircraft tail areas are now required to withstand impact with a 3.7 kg bird.

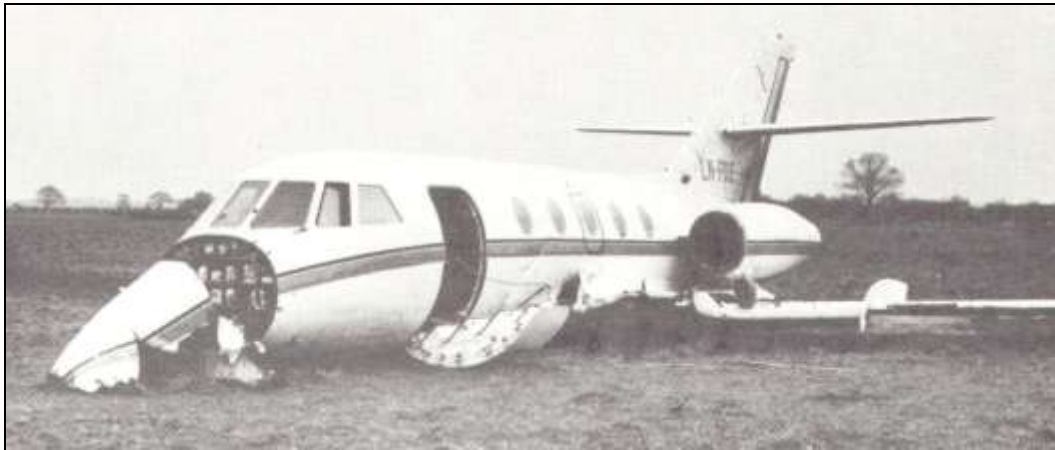
<b>12.12.73</b> LN-FOE	<b>Falcon 20</b> 2 GE CF700 turbine	Norwich, Norfolk, UK	Engines Gulls	9 3 minor injury
---------------------------	--	-------------------------	------------------	---------------------

The co-pilot a qualified commander on the type was flying the aircraft from the left hand seat. The aircraft took off for Gothenburg, Sweden at 15.37 hrs. As it became airborne about half way down the runway the pilot avoided two flocks of birds but between 1 and 200 ft collided with a third flock extending from the ground to well above the aircraft. There were multiple strikes and both engines were heard to run down and fail. The landing gear was still down and avoiding trees he force landed in a field about 1,000 metres off the runway end. All three landing gear legs were torn off and it came to rest on its belly. The two pilots and cabin attendant suffered cuts and bruises but the passengers were uninjured. A total of 35 gull carcasses (**Common gulls** *Larus canus*, 420 gm, **Black-headed gulls** *Larus ridibundus*, 275 gm) were found towards the end of the runway. Both engines had been damaged by one or more birds. Visibility from the Control Tower was restricted by the onset of darkness, and by condensation and rain on the windows. (Litigation was awarded against the airport).

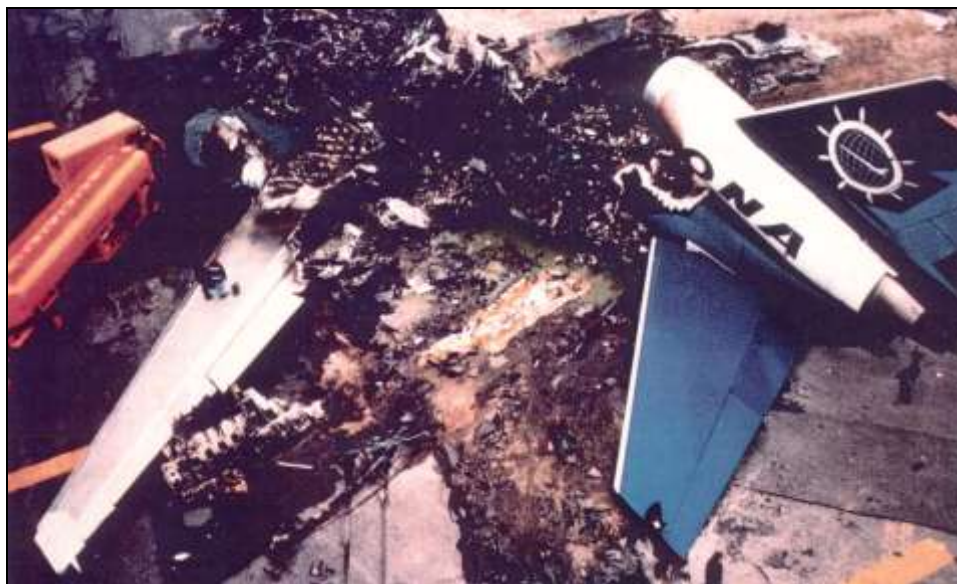
wet runway, number 3 engine disintegrated and caught fire. Several wheels and tyres failed and the captain steered the aircraft onto a taxiway where the landing gear collapsed and ultimately the aircraft was destroyed by fire. All on board were airline employees who escaped successfully although two received serious injuries.

Due to the loss of No 3 hydraulic system, number 2 brake system, number 3 engine thrust reversers and number 3 spoiler system were all unavailable. Engine imbalance caused the epoxy abrasible fan shroud to catch fire due to blade rub. Engine 3 ingested at least one Great black-backed gull and 9 more were found on the runway together with 13 Herring gulls. An Airworthiness Directive required replacement of the fan shroud material.

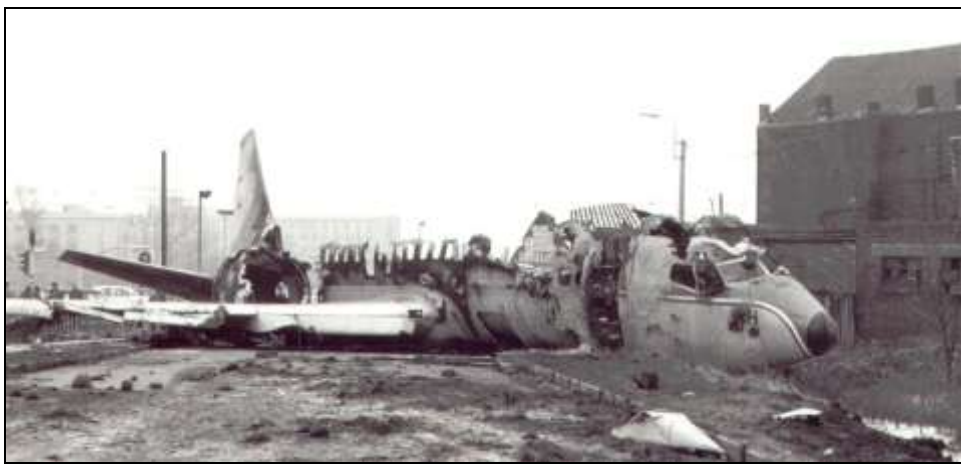
<b>04.04.78</b>	<b>Boeing 737</b>	Gosselies,	Engine	3
OO-SDH	2 P&W JT8D turbine	Belgium	Pigeon	Nil

A trainee co-pilot was making touch and go landings under the supervision of an instructor. As the aircraft was about to lift-off, a flock of **Woodpigeons**, (*Columba palumbus*, 465 gm) were seen ahead. Because he believed both engines might have ingested birds, the pilot abandoned the take-off even though the speed was beyond V1. The aircraft over-ran into an industrial estate with a collapsed right landing gear and the right engine torn from the wing. The wreckage ended up 300 metres from the runway on the extended centre-line and was destroyed by fire. Only the left engine was found to have suffered bird strike damage.

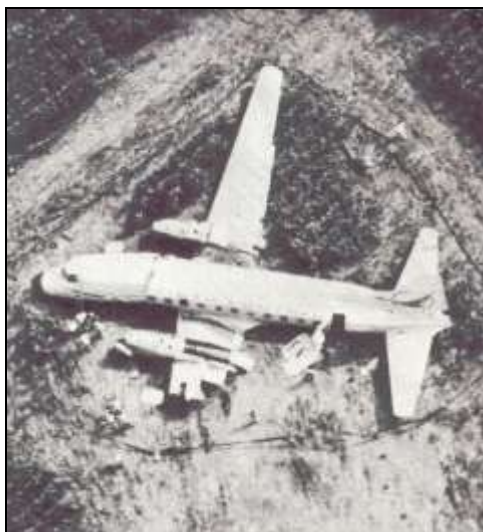
<b>25.07.78</b>	<b>Convair 580</b>	Kalamazoo,	Engine	43
N4825C	2 Allison 501 turboprop	Michigan, USA	Sparrowhawk	3 serious

As the North Central Airlines aircraft was taking off at 07.02, a **Sparrowhawk** (*Falco sparverius*, 105 gm) struck the left engine just as the aircraft passed V1. The left propeller auto feathered as the aircraft lifted off and it turned to the left and flew for 79 seconds before crashing in a cornfield. One crew member and two passengers were seriously injured. Investigation found that the probable cause was the failure of the captain to follow the prescribed procedures, allowing the aircraft to decelerate into a flight regime from which he could not recover, whilst inadequate cockpit co-ordination also contributed.

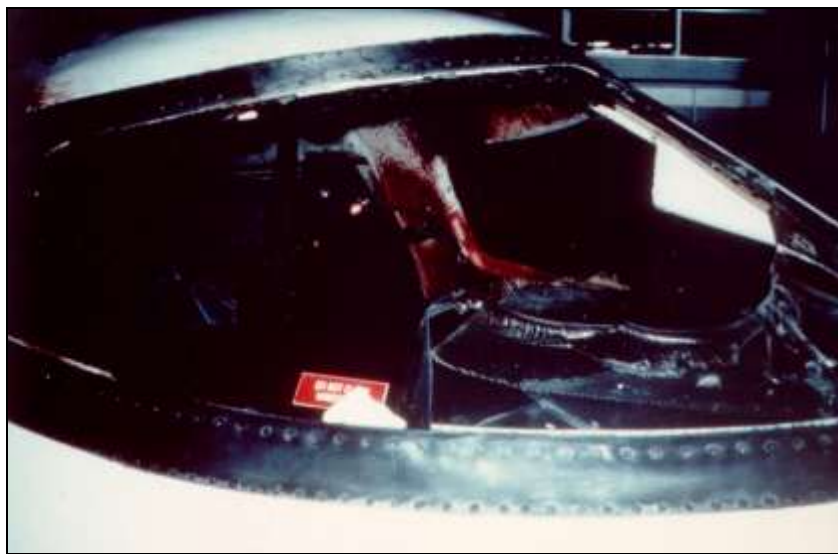
<b>07.04.81</b>	<b>Lear 23</b>	Lunken, Cincinnati	Windshield	2
N400PG	2 GE CJ610	USA	Loon	<b>1 fatal</b>

While climbing through 4,000 ft in a left turn, a **Loon** (*Gavia immer*, 3.7 kg) penetrated the right windshield killing the co-pilot and seriously injuring the pilot. Windshield debris damaged engine 2 which had to be shut down. Loss of hydraulics caused inoperative flaps and brakes and wind-blast resulted in communication difficulties. The injured pilot demonstrated great skill in returning to Lunken Airport. (Successful Litigation against aircraft manufacturer)

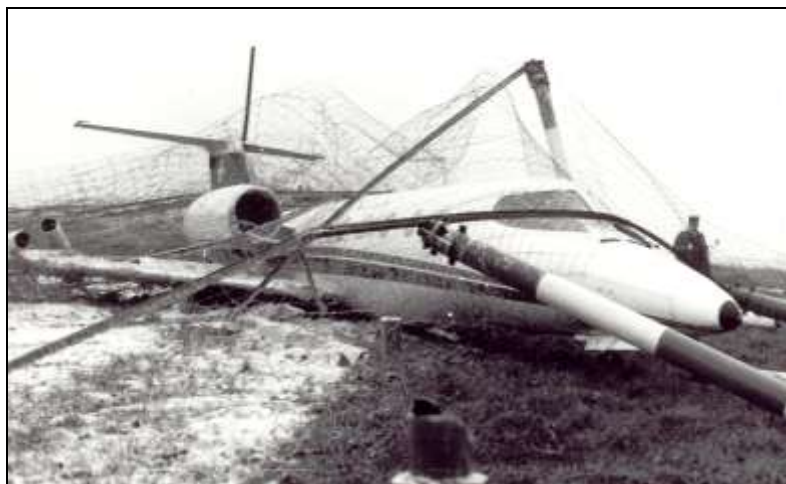
<b>06.12.82</b>	<b>Lear 35A</b>	Paris Le Bourget,	Nil	4
HB-VFO	2 Garrett TFE731 turbofans	France	Gulls	1 crew injury

As the aircraft was taking off on a wet runway, a flock of **Black-headed gulls**, (*Larus ridibundus* 275 gm) was encountered when the speed was above V1. Take-off was abandoned and the aircraft over-ran the runway by 56 metres into the ILS installation, which penetrated the cockpit injuring the co-pilot. The brake chute had failed and the emergency brake source was not used. Neither engine had suffered bird damage.

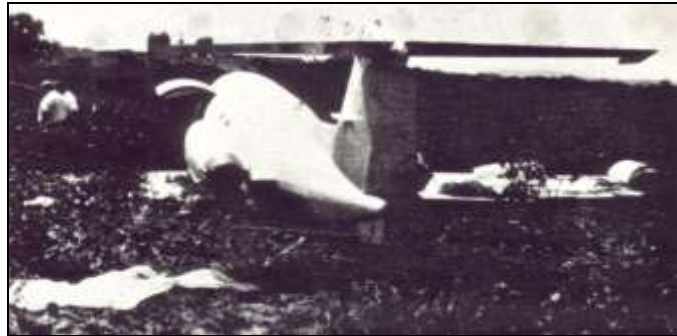
<b>17.08.83</b> N108PA	<b>Lear 25</b> 2 GE CJ610 turbine	Wilmington, USA	Engines Starlings	2 -
---------------------------	--------------------------------------	--------------------	----------------------	--------

At 500 ft after take-off, the aircraft passed through a flock of 200 **Starlings**, (*Sturnus vulgaris*, 80 gm). Both engines failed and the aircraft force landed, struck a tree between industrial buildings and bounced across a road into a field. There was no fire. The pilot reported it was only 10 seconds from the bird encounter to ground impact.

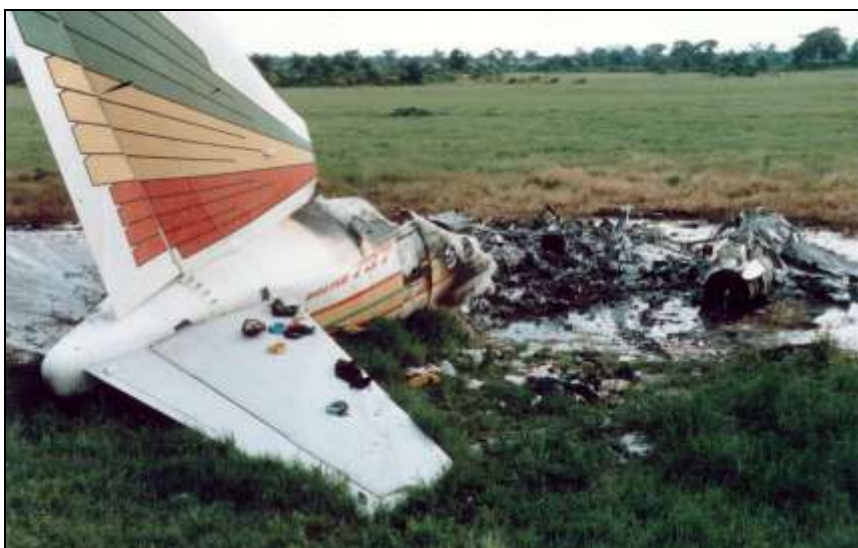
<b>15.09.88</b> ET-AJA	<b>Boeing 737</b> 2 P&W JT8D turbine	Bahar Dar, Ethiopia	Engines Pigeon	104 35 fatal, 21 injured
---------------------------	---	------------------------	-------------------	-----------------------------

During the take-off run of the Ethiopian Airlines aircraft at the airport 5,800 ft amsl, at a speed between V1 and VR the aircraft encountered a flock of **Speckled pigeons** (*Columba guinea*, 320 gm). These were ingested in both engines, which started to surge and lose power with loss of EPR and very high EGT. The gear was retracted, full power applied and a slow climb made in order to complete a circuit and return. The aircraft reached a maximum of 7,100 ft and 190 kts. On base leg about 3 ½ minutes after take-off both engines failed and a wheels up forced landing was attempted in open country about 10 km SW of the airport. The aircraft encountered a small riverbank disintegrated and caught fire. The airport only has 2 or 3 jet movements per week. It is believed 10 to 16 birds were ingested in each engine causing the fan damage and surging. The pigeons had been feeding on grass seed that had grown from soil brought to the airport to fill in trenches that had been dug for cable laying.

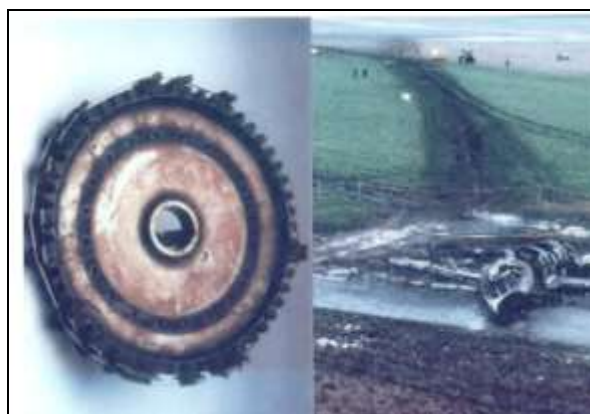
Just after the aircraft rotated on take-off on a charter flight to Romania from runway 25 at Paris, Le Bourget, it encountered a flock of **Lapwings** (*Vanellus vanellus*, 215 gm). A number were ingested in engine 1. The aircraft was climbing but the pilot reported he was returning due to an engine fire. A number of witnesses saw the rear of the aircraft engulfed in flames. A tight left hand circuit was flown at a height of about 500 ft agl in an attempt to land back on the runway. The aircraft was about 30° off the runway heading and landed heavily with 15° of left bank in a nose-down attitude just to the right of the runway close to the intersection with runway 21. The aircraft was destroyed by impact and fire. About 15 dead birds were found on the runway close to the point where the aircraft lifted off.

The engine rear cowling, exit guide vanes and a number of fan blades were found further along the runway whilst the fan disc with most of the blades sheared off at the root was found about 500 metres to the side of the runway. The fan had separated and shrapnel had penetrated the rear fuselage puncturing the engine feeder tank and fire had immediately broken out. The cockpit voice tape revealed that while taxiing the pilots had remarked 'look at those birds there'. The person responsible for airport bird control had gone off duty due to illness. There was considerable litigation involving the Airport Authority, and the aircraft and engine manufacturers. (The full 76 page Report is available in French on the French Accident Investigators web site <www.bea-fr.org>).

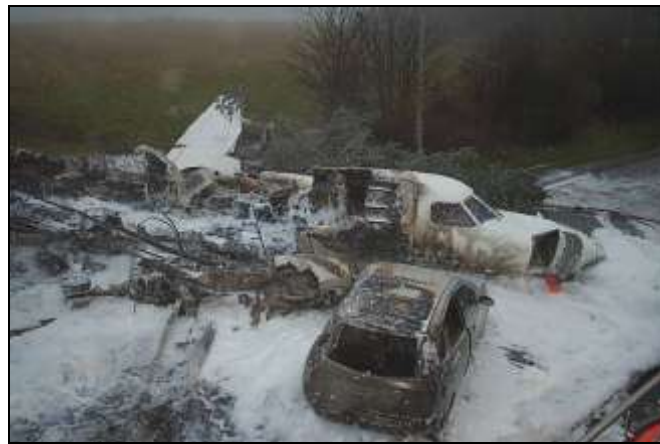
The aircraft descended and impacted with the ground some 500 metres to the right of the runway slid along a field and onto a public road and collided with a moving car.

The foam covered wreckage of the Metro on the road

The right wing was on fire and the crew left the aircraft via the left door and co-pilot checked that no one was trapped in the car, they then moved well away from the intense fire along with the car driver. Bird remains were found where the aircraft had rotated and were identified as two Herring gulls (*Larus argentatus*, 1.1 kg), one Common gull (*Larus canus*, 420 gm) and one Black-headed gull (*Larus ridibundus*, 275 gm). Large portions of the Herring gulls were missing. The left engine was found to have ingested at least part of a bird and a first stage impeller blade had been distorted with feather residue in the combustion chamber. There was no ingestion in the right engine. An Operations Officer had inspected the runway at 05.55 and had dispersed some birds which had not returned at the time he completed his next inspection at 07.05. Between then and the departure of OY-BPH there had been four movements. (19 page report in AAIB Bulletin 6/2004, available on [www.aaib.gov.uk](http://www.aaib.gov.uk))

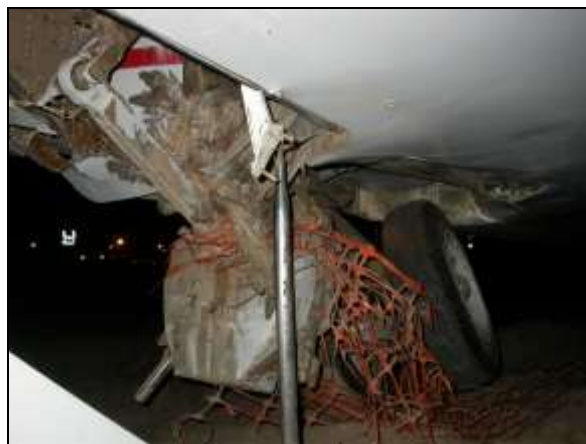
<b>29.11.04</b> PH-BTC	<b>Boeing 737-406</b> 2 CFM56	(Barcelona, Spain) strike - Amsterdam	Landing gear Buzzard	146 on board 10 minor
---------------------------	----------------------------------	--	-------------------------	--------------------------

Shortly after take off from Amsterdam-Schiphol, the crew of the KLM aircraft experienced a bird strike. They re-cycled the landing gear resulting in normal indications. After consultation with KLM Engineering it was decided that as there were no indications of anything abnormal, the flight continued to its planned destination of Barcelona where an inspection would be made. On landing the pilots were unable to keep the aircraft on the runway by use of rudder, differential reverse or nose wheel steering. The aircraft left the runway at about 100 kts into an area of work-in-progress next to the runway. During the emergency evacuation at about 18.50 hrs local of the 140 passengers and 6 crew, 10 people were treated on the spot for minor injuries with two needing hospital treatment. The bird remains were identified as a buzzard (*Buteo buteo*, 800gm) and were found in the nose gear jamming the steering cables to one side. Due to the landing gear damage and engine ingestion of debris from the runway work, the aircraft is likely to be deemed a constructive write off. The accident is under investigation.

**Photo of Buzzard in nose gear bay** courtesy of Dani Burgas (Minuartia, Estudis Ambientals), with the permission of AENA (Barcelona Airport) and KLM Station Manager Barcelona.

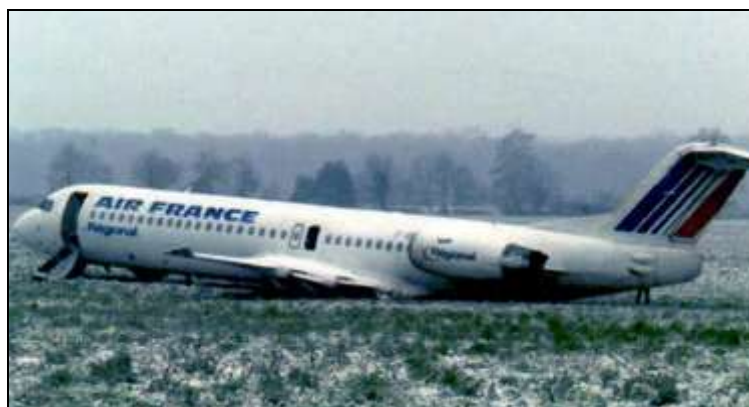
<b>25.01.07</b>	<b>Fokker F28-100</b>	Pau-Pyrénées Airport,	Nil	54 on board
F-GMPG	2 x RR Tay turbofans	France	Lapwings?	1 3 <sup>rd</sup> Party, Nil inj

The aircraft was taking off at 10.26 hrs from runway 13 at Pau Pyrénées, 616 ft amsl, France for Paris Charles de Gaulle. Just as the aircraft lifted off at 128 kts birds were seen. The Captain, the handling pilot, rotated the aircraft at 6.1 degrees per second, instead of the more usual 1.3 to 3°/sec reaching 11.9°. Control was lost as it suddenly banked left to 35° followed by 67° to the right. It reached a height of 107 ft before descending and bounced off the right main landing gear and the captain abandoned take-off at a speed of 160 kts. Engine power was reduced and it contacted the ground again near the end and to the right of the runway. The thrust reversers were briefly deployed. The aircraft ran 340m off the end of the runway, crossing a road where the left main landing gear struck a truck, killing the driver. Both main gears were sheared off as the airplane continued 535m into a field. There was no fire and the aircraft was evacuated without injury. No birds struck the airframe or engines. The accident resulted from a loss of control caused by the presence of ice on the wings and by the rapid rotation reflex reaction to a flock of birds. The temperature was 0°C, dew point -1 and humidity above 90% defined in the Operations Manual as icing conditions. The Operator did not have anything available to enable the crew to check for ice on the wings. An Airbus A320 had an iced wing and had defrosted the aircraft. The birds were thought to be Lapwings (*Vanellus vanellus*, 215 gm) which are prevalent on the airport in January and February. Three bird inspection runs had been made prior to the accident, nothing had been seen. The Pilot was charged with

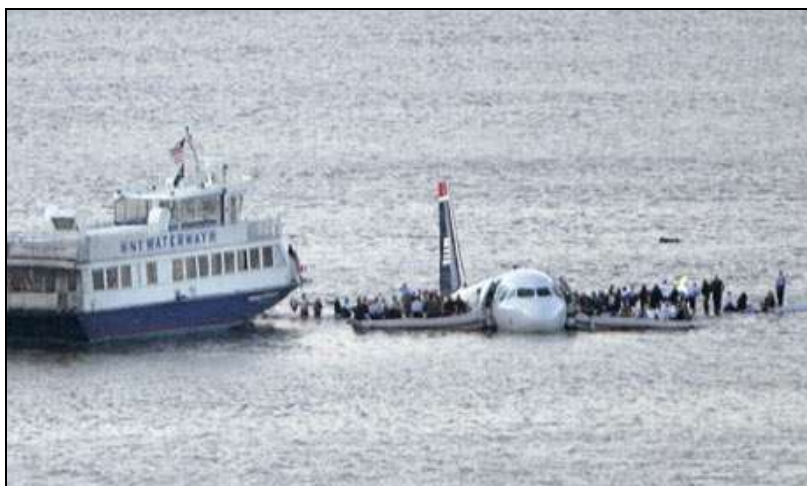
<b>15 01.09</b> N106US	<b>Airbus A320</b> 2 x CFM56-5	Hudson River, New York USA	Engines Canada geese	155 on board 1 serious inj
---------------------------	-----------------------------------	-------------------------------	-------------------------	-------------------------------

The US Airways Flight 1549 took off at 15:26 from New York La Guardia's runway 04 for Charlotte, Carolina. The first officer was handling pilot. As they were reaching an altitude of 3,200 feet the crew encountered a formation of Canada geese (*Branta Canadensis*, 3.6 kg). Impacts were felt and both engines began to lose power and there was a burning smell. The captain took over control of the flight while the first officer attempted to relight the engines. ATC were informed that they had lost thrust in both engines and were turning back toward LaGuardia. It quickly became evident that they were not able to reach LaGuardia and the possibility of Teterboro, New Jersey was considered. The captain realized that it was too far stated his intention of going for the Hudson River. They descended over the George Washington Bridge and ditched opposite mid-town Manhattan. The occupants evacuated the aircraft onto the wing and aboard escape slide rafts. Coast Guard, commuter and tour vessels rescued everyone on board in spite of some people in the water and the strong current. The maximum altitude reached was 3,200 feet and the last radar return received was at 300ft and 153kts. The aircraft was retrieved from the river. Both DNA and feather analysis confirmed that both engines had ingested Canada geese. It was fortunate the captain had considerable gliding experience. (NTSB Report AAR-10/03).

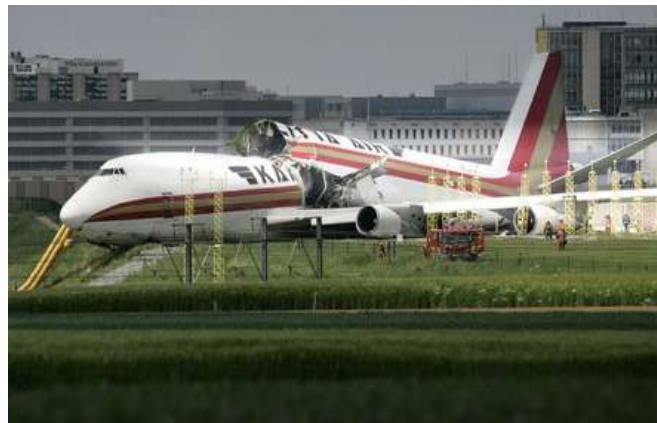
<b>25 .05.09</b> N704CK	<b>Boeing 747F-200</b> 4 x P & W JT9D	Brussels Airport, Belgium	Engine Kestrel	5 on board 5 uninjured
----------------------------	--	------------------------------	-------------------	---------------------------

The Kalitta Air flight was a cargo flight from New York-JFK to Bahrain with a technical stop at Brussels with 73 tonnes of cargo. The Boeing 747 was taking off at 13.30 from runway 20 (2,987 m) when the right engine experienced a momentary loss of power accompanied by a loud bang, heard by the crew and external witnesses, and by flames, seen from the control tower. CVR data revealed this was 4 seconds after V1. Two seconds later and in spite of being 6 seconds past V1, the take off was abandoned. All four engines were brought back to idle, and braking action was initiated but the thrust reversers were not deployed. The aircraft came to a stop 300m beyond the end of the runway, above a railway embankment. The aircraft was severely damaged; breaking into three parts. The crew were highly experienced the Captain having over 15,000 hrs with 3,000 on the B747. DNA revealed a Kestrel (*Falco tinnunculus*, 200 gm) strike. (Belgian Investigators Preliminary Report)

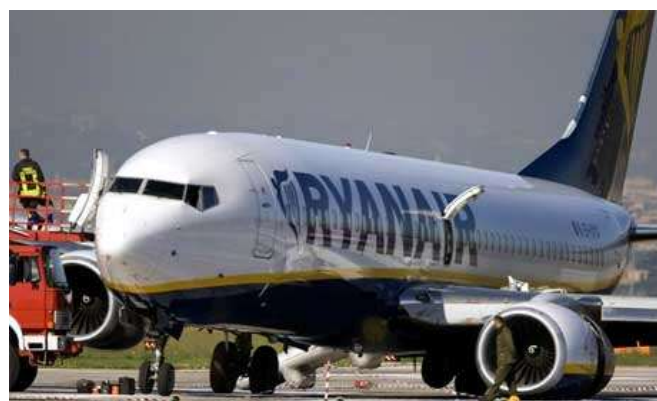
At about 7.56 am while below 500 ft on short finals to land, the Ryanair flight from Frankfurt Hahn, encountered an enormous starling flock (*Sturnus vulgaris*, 80 gm). The First Officer as pilot flying initiated an immediate go-around but there were multiple strikes on the nose, wings, windshield and both engines lost power with burning smell and vibration. Engines did not respond and remained at 40% N1 so elected to land. The aircraft impacted hard with stick shaker and the left hand landing gear was forced into the aircraft structure. The aircraft slid to a halt on the runway with one engine resting on the runway. One person was injured when evacuating via the one slide which had been deployed, the rest were evacuated via steps. The aircraft has been written-off. (*Italian Report awaited*).
