## 100 YEARS OF FATALITIES AND DESTROYED CIVIL AIRCRAFT DUE TO BIRD STRIKES

John Thorpe, FRAeS Aviation Safety Adviser & Former IBSC Chairman  
Brackens, Chapel Road, Smallfield, Surrey, RH6 9JH, UK  
0044 1342 842594, [johnthorpe@flysafe.fsnet.co.uk](mailto:johnthorpe@flysafe.fsnet.co.uk)

At the 1996 London and 2003 Warsaw meetings of the International Bird Strike Committee, illustrated Working Papers were presented that provided brief details of **all** known fatalities and destroyed aircraft due to bird strikes between 1912 and 2002. These papers were felt to be useful in drawing attention to the scale of the problem especially when dealing with those who know little about the subject or who are newly appointed to decision-making positions. Since the original papers were published, updated information has been provided in Papers presented at IBSC Meetings in Athens, Brasilia and Cairns. This 36 page Paper consolidates and updates the information and analysis.

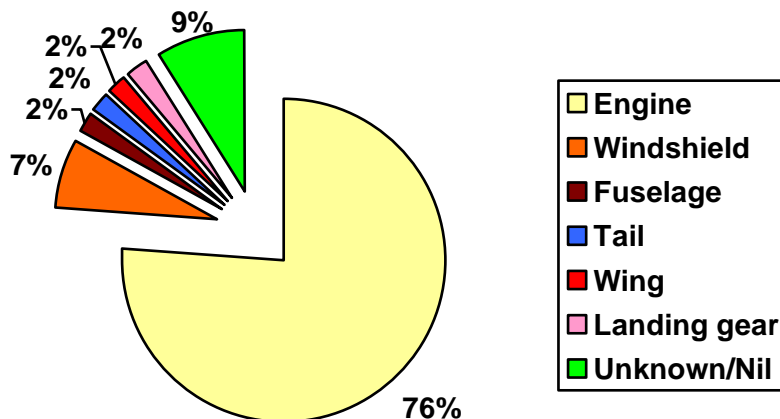
Fig. 1 – Part Struck

b). In Fig. 1 it can be seen that engine damage was the cause of 76% of the accidents in this group, followed by windshields with 7%. In recent years a high proportion are early Russian aircraft operating at airports, often in third world countries, where control measures are unlikely.

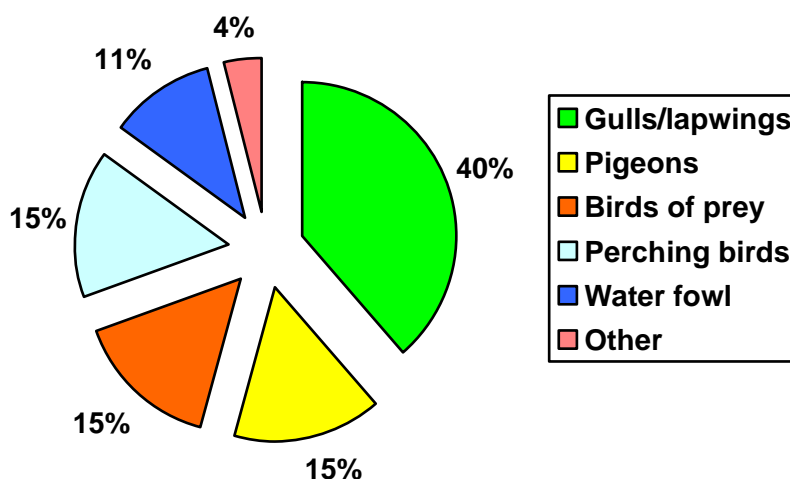
**Fig.2 - Bird Species – where known**

f). Where the bird species is known (68% of 30 cases) it can be seen in Fig. 2 that gulls (*Larus sp.*) are the major cause of the accidents followed by birds of prey (*Accipitriformes*), pigeons (*Columbiformes*) and water fowl (*Ciconiiformes & Anseriformes*).

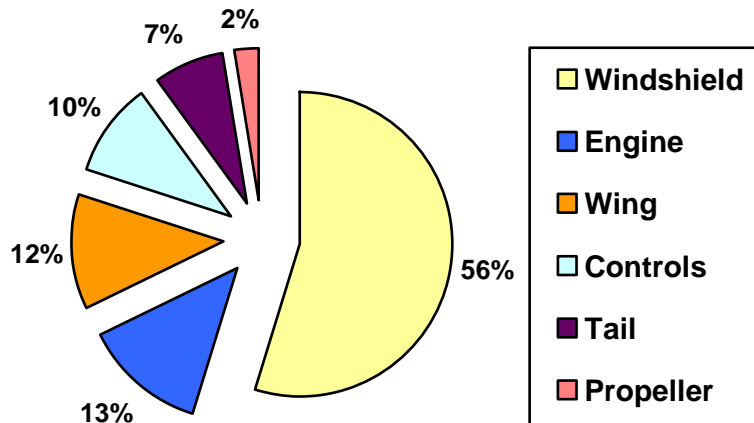
**Fig. 3 - Part Struck - where known**

b). In Fig. 3 it can be seen that the windshield is struck in 54% of accidents with the engine and the wing in 12.5% of cases followed by controls with 10% and the tail at 8%. Pilots who habitually fly fast at low level or in a bird-rich environment should consider wearing head protection with visor or goggles. Many single-engine training aircraft such as the Cessna 152 and Piper PA28 fly at a modest speed which enables birds to get out of their way; past evidence shows that up to about 80 kts birds can successfully avoid an aircraft. Currently, it is the homebuilt/kit built aircraft that have a considerably higher cruising speed bearing in mind that impact force is proportional to the square of the collision speed so that a small increase in speed results in a big increase in the impact force.

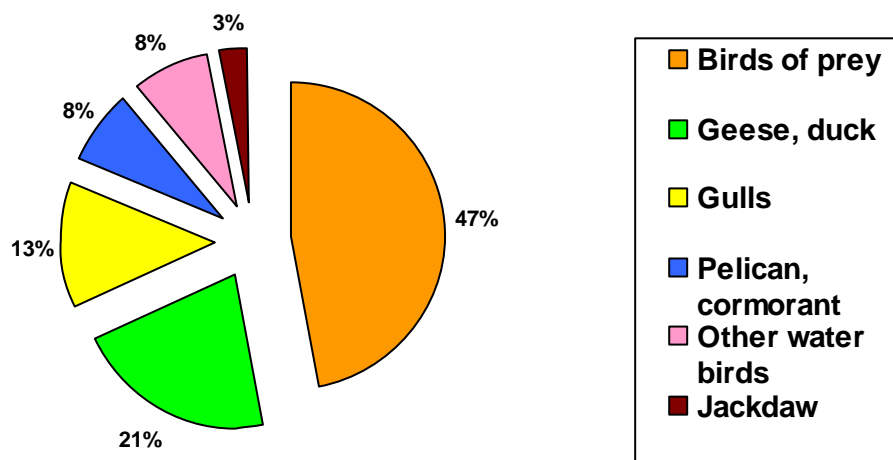
**Fig. 4 - Bird Species - where known**

d.) Fig. 4 shows that the where known, (67% of cases), birds causing general aviation accidents are markedly different from those of transport sized aeroplanes. In these cases the major threat is birds of prey (*Accipitriformes*), which are frequently heavy and have little or no fear of other airspace users, causing 47% of the accidents. The group comprising geese and ducks (*Ciconiiformes* & *Anseriformes*), which are also heavy, caused 21% followed by gulls (*Larus sp.*) at 13%.

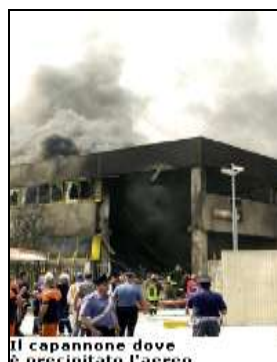
<b>01.06.03</b>	<b>Lear 45</b>	Milan Linate,	Engine(s)	2 on board
I-ERJC	2 TFE 731 turbofan	Italy	Feral pigeons	<b>2 killed</b>

The aircraft owned by Eurojet Italia, was taking off for Genoa, Italy with two crew on board to collect the famous Italian architect Renzo Piano and take him to Paris. The crew reported a birdstrike stating they were returning. The pilot's voice was reported to be calm and everything seemed under control. A policeman near the accident site reported that the engine was making a strange noise right from take-off. At the end of the downwind leg, approximately 1,000 ft from the threshold it crashed into a warehouse, fortunately unoccupied on a Sunday, and was destroyed by fire. At least six bird fragments identified as Feral pigeons (*Columba sp.*) were found on the runway. An unconfirmed report suggests that the flock came from outside the airport, suddenly crossed the runway during the take-off heading for other off-airport buildings. At least one engine ingested birds and failed, it is not yet known if the remaining engine also failed or if control of the aircraft was lost. The accident was close to the most important cycle race in Italy with thousands of spectators lining the race route through the suburbs, it resulted in extensive TV and press coverage. Investigation could lead to criminal charges against a number of individuals.

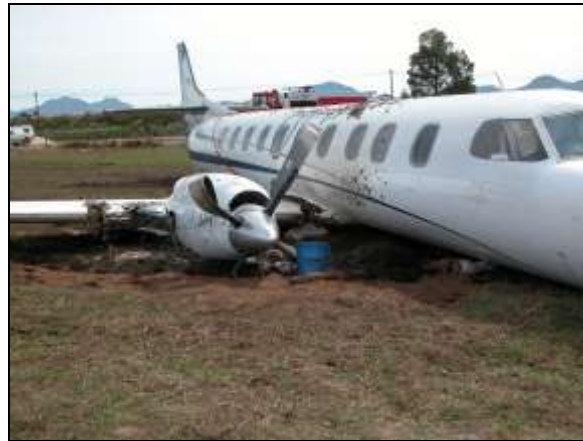
<b>10.09.04</b> ZS-OLS	<b>SA227 AC Metro 3</b> 2 Garrett TPE331	George Airport South Africa	Engine Spotted thick-knee	2 on board Minor
---------------------------	---	--------------------------------	------------------------------	---------------------

The aircraft operated by Skyhaul (converted to cargo), was carrying freight from Bloemfontein Airport and was on final approach at a time when the airport was not yet open, 05.40 hrs. While over-flying at 200ft a Spotted thick-knee (*Burhinus capensis*, 425gm) was ingested in engine 2 resulting in the aircraft failing to gain height during the attempted go-around. The aircraft came down in open countryside and was sufficiently damaged that it has been written off. The two crew suffered minor injuries. There was clear evidence of engine fan damage. The aircraft weight at the time of the accident is under scrutiny.

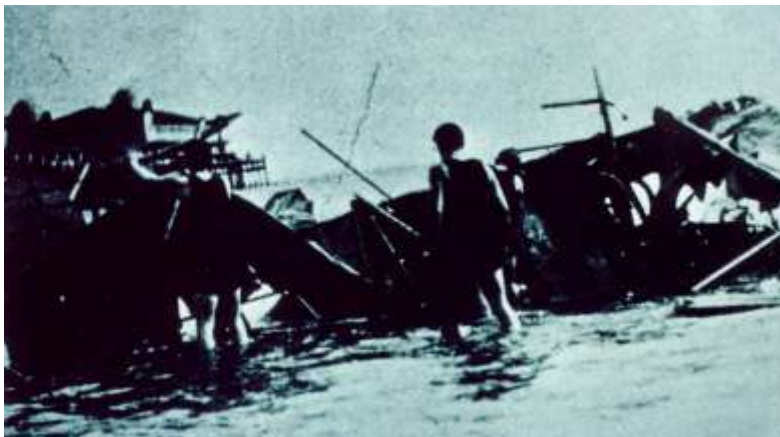
03.04.12	<b>Wright Flyer</b>	Long Beach	Controls	1
-	1 piston	California, USA	Gulls	<b>1 fatal</b>

Cal Rogers the first person to fly across the USA was making a demonstration flight along the beach when he encountered a flock of **gulls**, (*Larus sp.*). One of them jammed the rudder control causing the aeroplane to dive into the surf breaking the pilots neck.

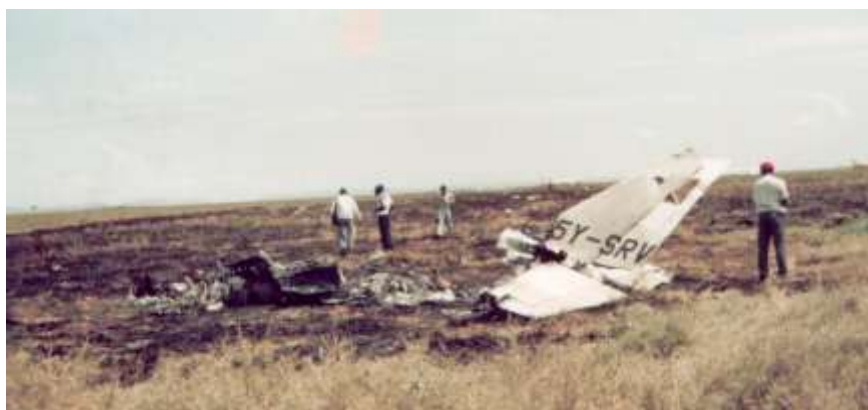
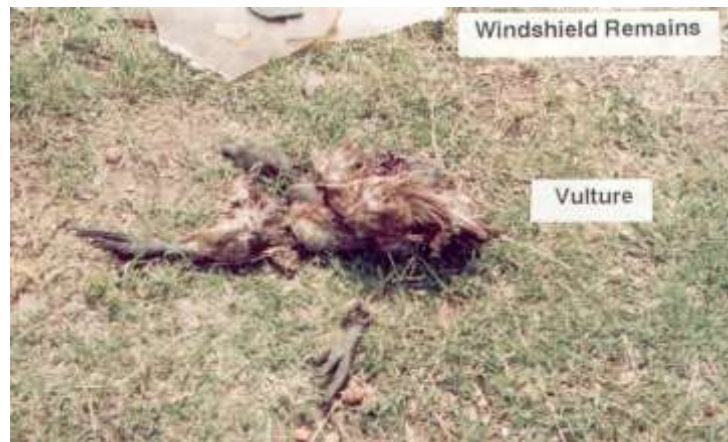
<b>26.12.91</b> 5Y-SRV	<b>Piper PA31 Navajo</b> 2 piston	Musiara, Maasi- Mara, Kenya	Windshield Vulture	9 <b>9 fatal</b>
---------------------------	--------------------------------------	--------------------------------	-----------------------	---------------------

A DC3 had suffered a collapsed landing gear and had over-run the runway. The PA 31 flew over the site, which was not its destination, probably to show the passengers. At about 250 ft and a fairly high cruise speed it struck a **White-backed vulture** (*Gyps africanus*, 5.4 kg). It oscillated, banked and pitched down uncontrollably before crashing and burning just beyond the end of the runway killing all occupants. Witnesses had seen a black object fall from the aircraft, these were found to be the vulture and part of the windshield. The autopsy on the pilot revealed pre-impact spinal injuries.

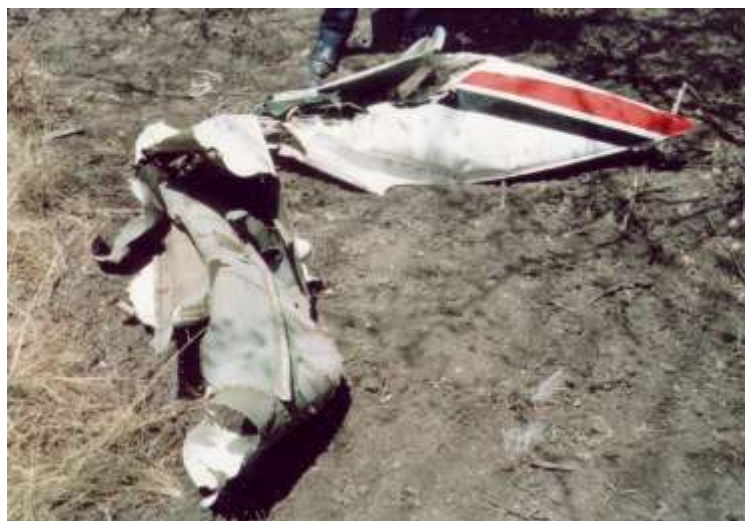
<b>25.01.92</b>	<b>Cessna 401</b>	Maasi-Mara,	Controls	7
5Y-BGW	2 piston	Kenya	Marabou stork	<b>7 fatal</b>

While in the cruise another aircraft heard a radio transmission “I have been hit by a large bird and I’m having difficulty flying it, I can hardly control the aircraft”. It crashed killing all occupants. The wing tip fuel tank and aileron were found about one mile from the main wreckage. Avian blood believed to be from a **Marabou stork** (*Leptopilos crumeniferus*, 5.9 kg) was found on the wing leading edge.

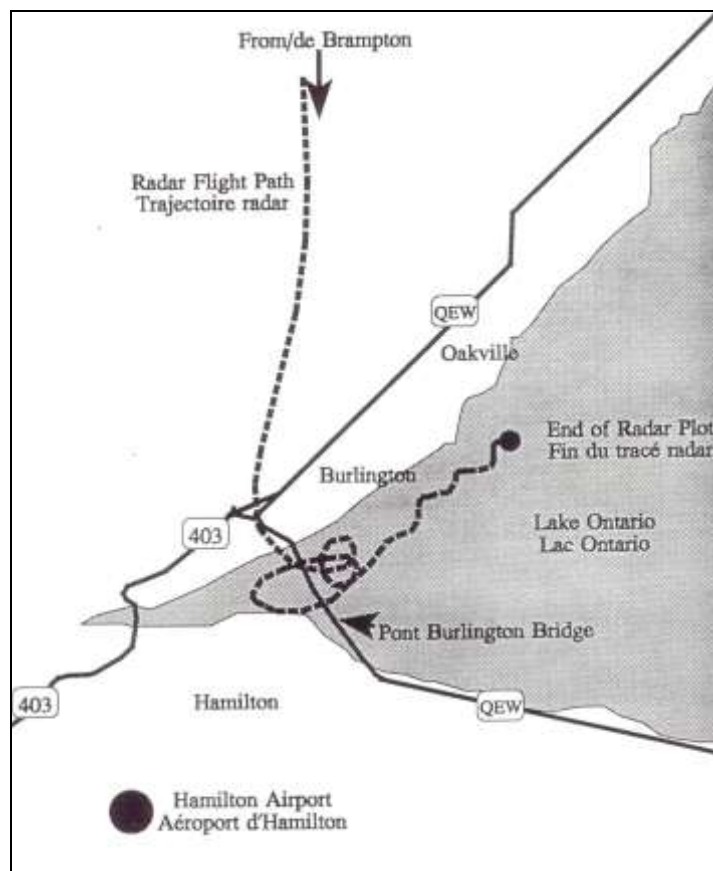
<b>24.02.94</b> C-GXGB	<b>Piper PA28 Warrior</b> 1 piston	Lake Ontario, Canada	Windshield -	1 <b>1 fatal</b>
---------------------------	---------------------------------------	-------------------------	-----------------	---------------------

While flying from Brampton to Hamilton Airport, Ontario, at 13.22 the 17,000-hour pilot was instructed to hold over the bay because of IFR traffic. At 13.34 he told ATC that something had come through the windshield, that he could hardly see and was disoriented. Six minutes later radar showed the aircraft in an 'S' pattern over the lake before it disappeared 14 miles NE of Hamilton airport. An aviation witness on the ground reported the weather was sunny, visibility unlimited and cloud base 5,000 ft. There has been no trace of the aircraft.

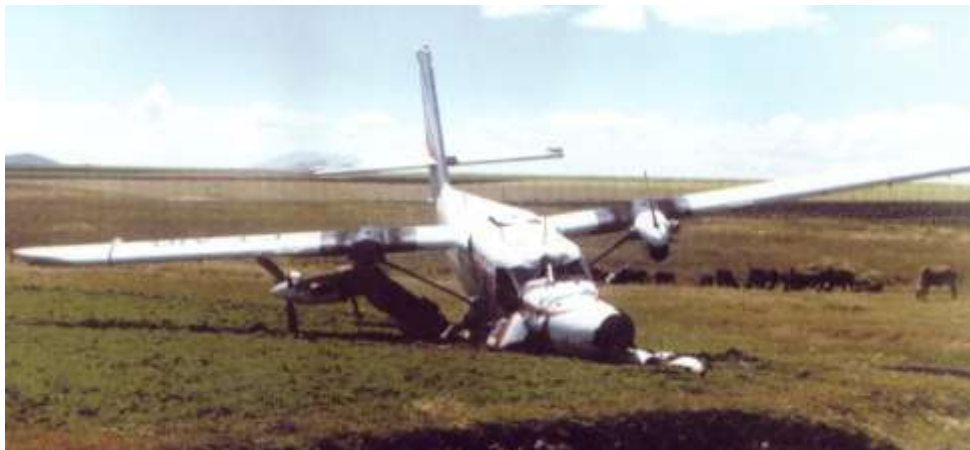
<b>22.10.95</b> ET-AIO	<b>DHC-6 Twin Otter</b> 2 turboprop	Bole Airport, Ethiopia	Windshield Vulture	20 4 serious
---------------------------	--	---------------------------	-----------------------	-----------------

About 20 miles from Addis Ababa, the aircraft collided with a **White-backed vulture** (*Gyps africanus*, 5.4 kg). It struck the windshield causing the support structure and both windshields to fail and collapse into the cockpit. The crew, although injured, maintained some control and continued to Bole airport. On arrival they were unable to position the aircraft correctly for landing and rather than go-around force landed some 300 metres south of the runway. During the ground run it fell into a depression and sustained damage beyond economic repair.

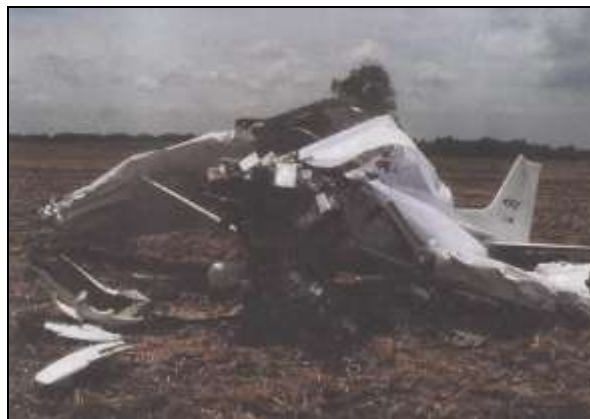
<b>08.07.03</b> N166ME	<b>Cessna 172 Skyhawk</b> 1 piston	McKinney, Frisco Texas, USA	Wing Vulture?	2 on board <b>2 killed</b>
---------------------------	---------------------------------------	--------------------------------	------------------	-------------------------------

The aircraft was at about 800 ft on it's way to the training company designated practice area when the 1,100 hour flight instructor made a Mayday call that a bird (most likely a vulture) had impacted with the left wing, could not keep the aircraft straight with power on and they were going down. A witness saw the aircraft flying over at 500 to 1,000 ft and said the wings were pitching up and down and looking uncontrollable with the tail swinging from side to side. Marks at the accident site, about 2 nm from the airport and crush angles were consistent with it stalling prior to impact killing both occupants.

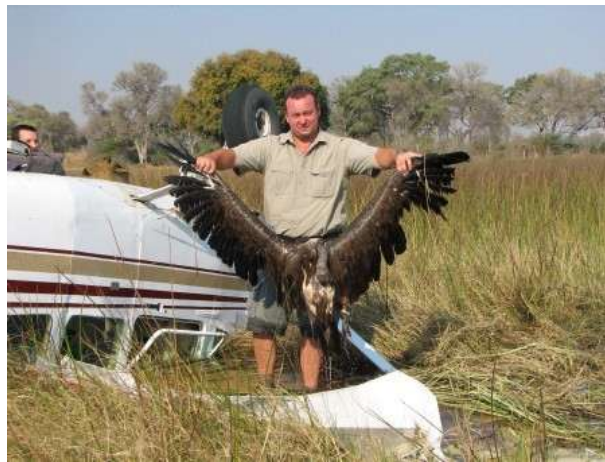
<b>26.09.06</b> A2-	<b>Cessna 206</b> 1 Continental TSIO-520	over Okavanga Reserve, Botswana	Windshield Vulture	5 on board <b>destroyed</b> , Nil injuries
------------------------	---	------------------------------------	-----------------------	---

The aircraft was flying at 2,500 ft agl over the Okavango nature reserve en-route from Nxabega to Tsigaro when a vulture smashed through the pilot's windshield destroying some of the instruments panel and becoming entangled in the flight controls. The pilot managed to shove the bird aside and regain control but the excessive drag from the holed windshield prevented the aircraft from maintaining height. The pilot force landed in the swamp resulting in the aircraft overturning. All five on board escaped with minor injuries thanks in part to the 4 point harnesses fitted to all seats by FMS. The ELT signal was picked up by Cape Town and the Rescue Co-Ordination centre alerted. The bird was identified as an **African white-backed vulture** (*Gyps africanus* wt 5.8 kg).

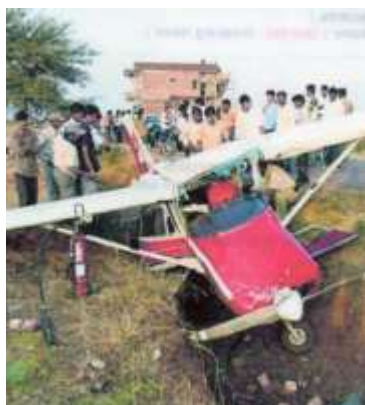
<b>04.02.07</b> VT-	<b>Cessna 152</b> 1 x Lycoming O-235	Nr Nadergul India	Windshield 'Eagle'	2 on board <b>1 minor injury</b>
------------------------	---	----------------------	-----------------------	-------------------------------------

Whilst returning to the airfield an **'eagle'** struck the windshield smashing it and causing the aircraft to 'spin out of control'. The aircraft crash landed in a field, the student suffering a deep cut on her forehead. The aircraft was very badly damaged in the forced landing. It was the first case in 10 years.

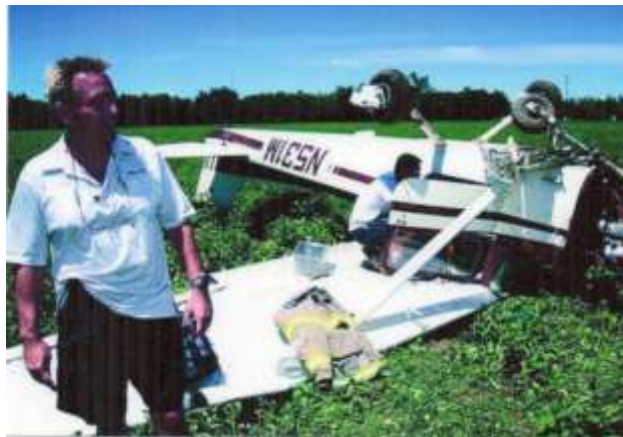
<b>21.07.07</b> N531M	<b>Cessna 150</b> 1 x Continental 0-200	Woodland, California, USA	Windshield 'Hawk'	2 on board Nil inj
--------------------------	--	------------------------------	----------------------	-----------------------

Shortly after take off on a student training flight a 'hawk' came through the windshield causing minor injuries. The drag prevented the aircraft from maintaining level flight resulting in a forced landing in a field. The aircraft overturned in the soft ground and was damaged such as to be a write off.

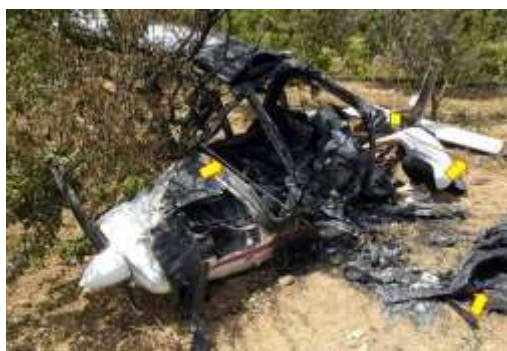
<b>28.06.08</b> CS-XAK	<b>Jabiru SK</b> 1 x Jabiru 2200	Tavira, Algarve Portugal	Nil -	2 on board 1 minor inj
---------------------------	-------------------------------------	-----------------------------	----------	---------------------------

At about 11.00 hrs after flying from Portimão the three axis microlight was on the final approach about 1 km from the landing strip when the pilot dodged a bird by turning and diving. The aircraft struck power lines which became entangled with the aircraft. It crashed 180 metres from the displaced threshold. The two occupants escaped, the pilot suffering a minor arm injury but the aircraft was destroyed by fire.

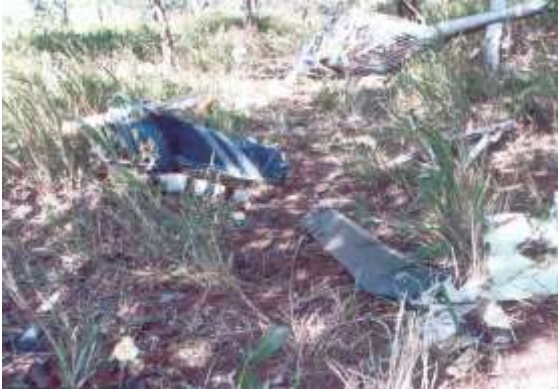
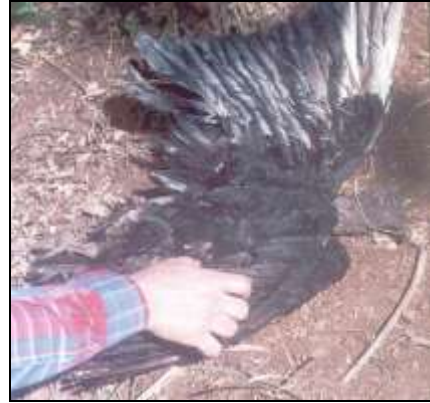
<b>27.01.00</b> HP-2599	<b>Bell 407 Long Ranger</b> 1 turbine	Nr Playa Leona, Nr Panama City,	Windshield Black vulture	5 <b>2 fatal, 3 serious</b>
----------------------------	--	------------------------------------	-----------------------------	--------------------------------

While about 25 nm SW from Panama City, Panama and at about 1,500 ft and 90 kts, a bird, identified as a **Black vulture** (*Coragyps atratus*, 1.7 kg), penetrated the windshield and struck the pilot knocking him unconscious. He fell across the controls and the co-pilot attempted to take over but the helicopter crashed onto a hillside and rolled down a slope. The pilot and one passenger were killed and the co-pilot and two passengers were seriously injured. The dead bird was found in the cockpit.
